# Allied-Axis

THE PHOTO JOURNAL OF THE SECOND WORLD WAR

# Contents

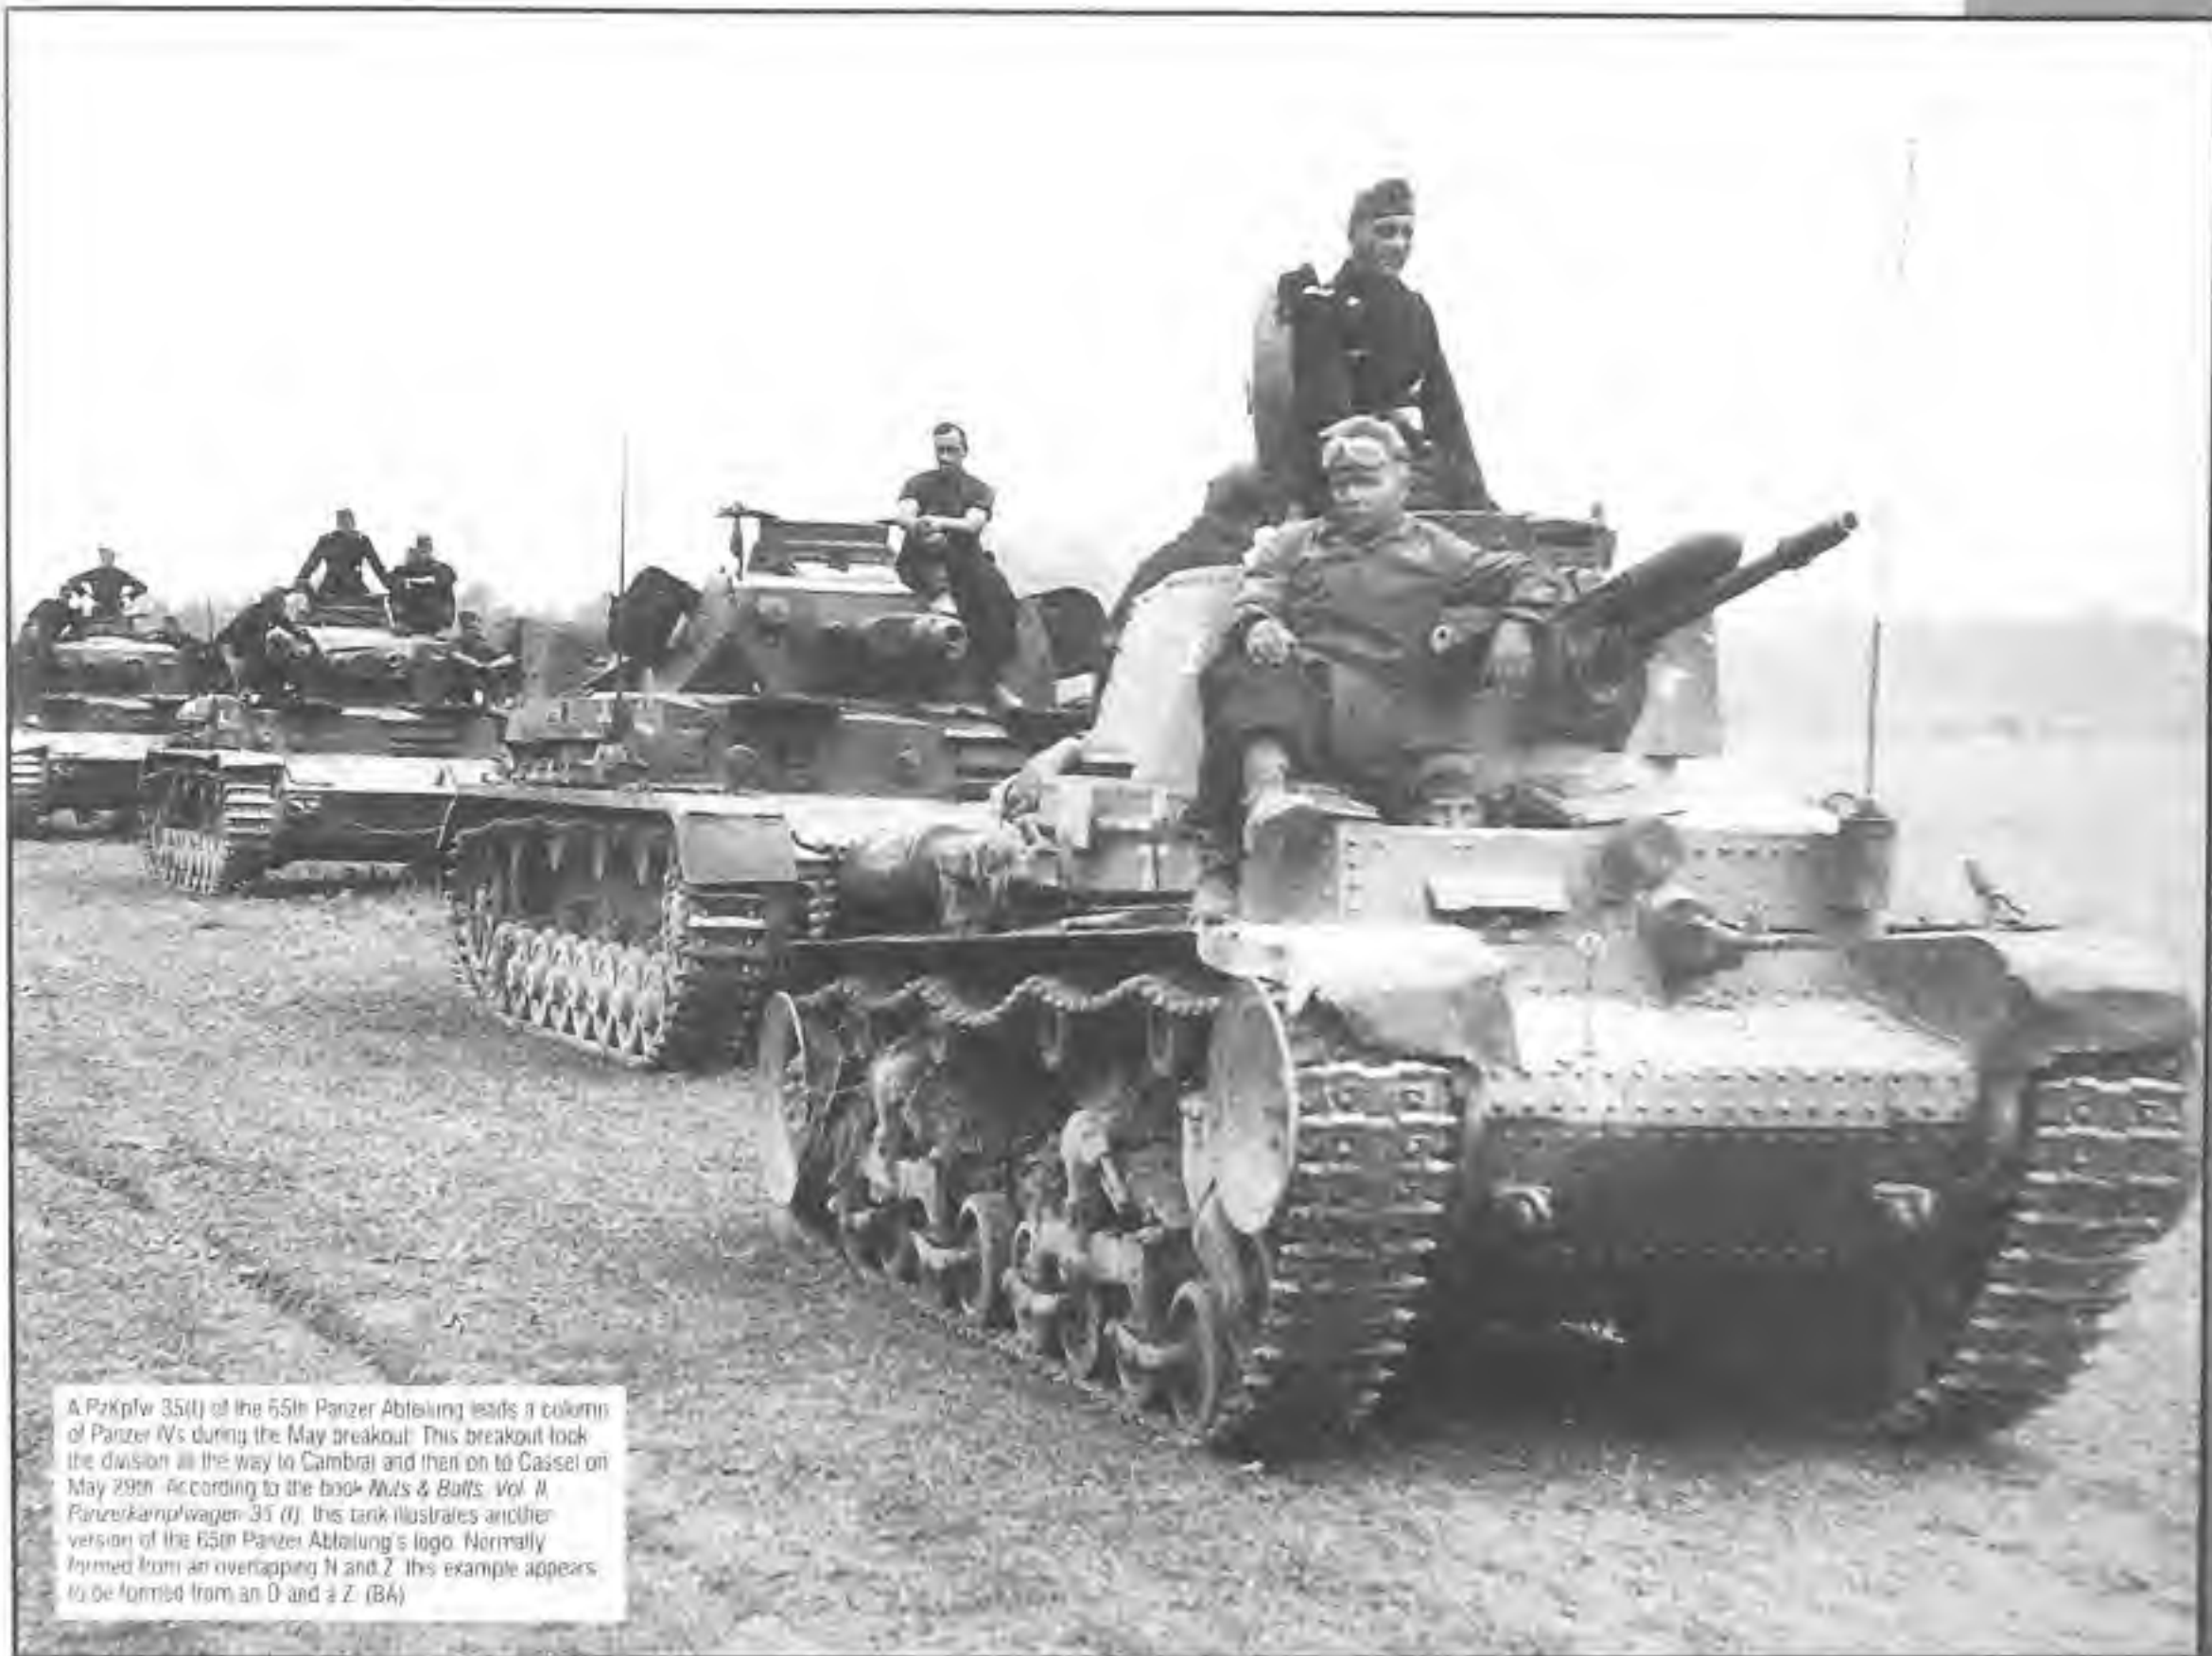
A PzKpfw 35(t) of the 65th Panzer Abteilung leads a column of Panzer IVs during the May breakout. This breakout took the division all the way to Cambrai and then on to Cassel on May 29th. According to the book *Nuts & Bolts, Vol. II, Panzerkampfwagen 35 (t)*, this tank illustrates another version of the 65th Panzer Abteilung's logo. Normally formed from an overlapping N and Z, this example appears to be formed from an O and a Z. (BA)

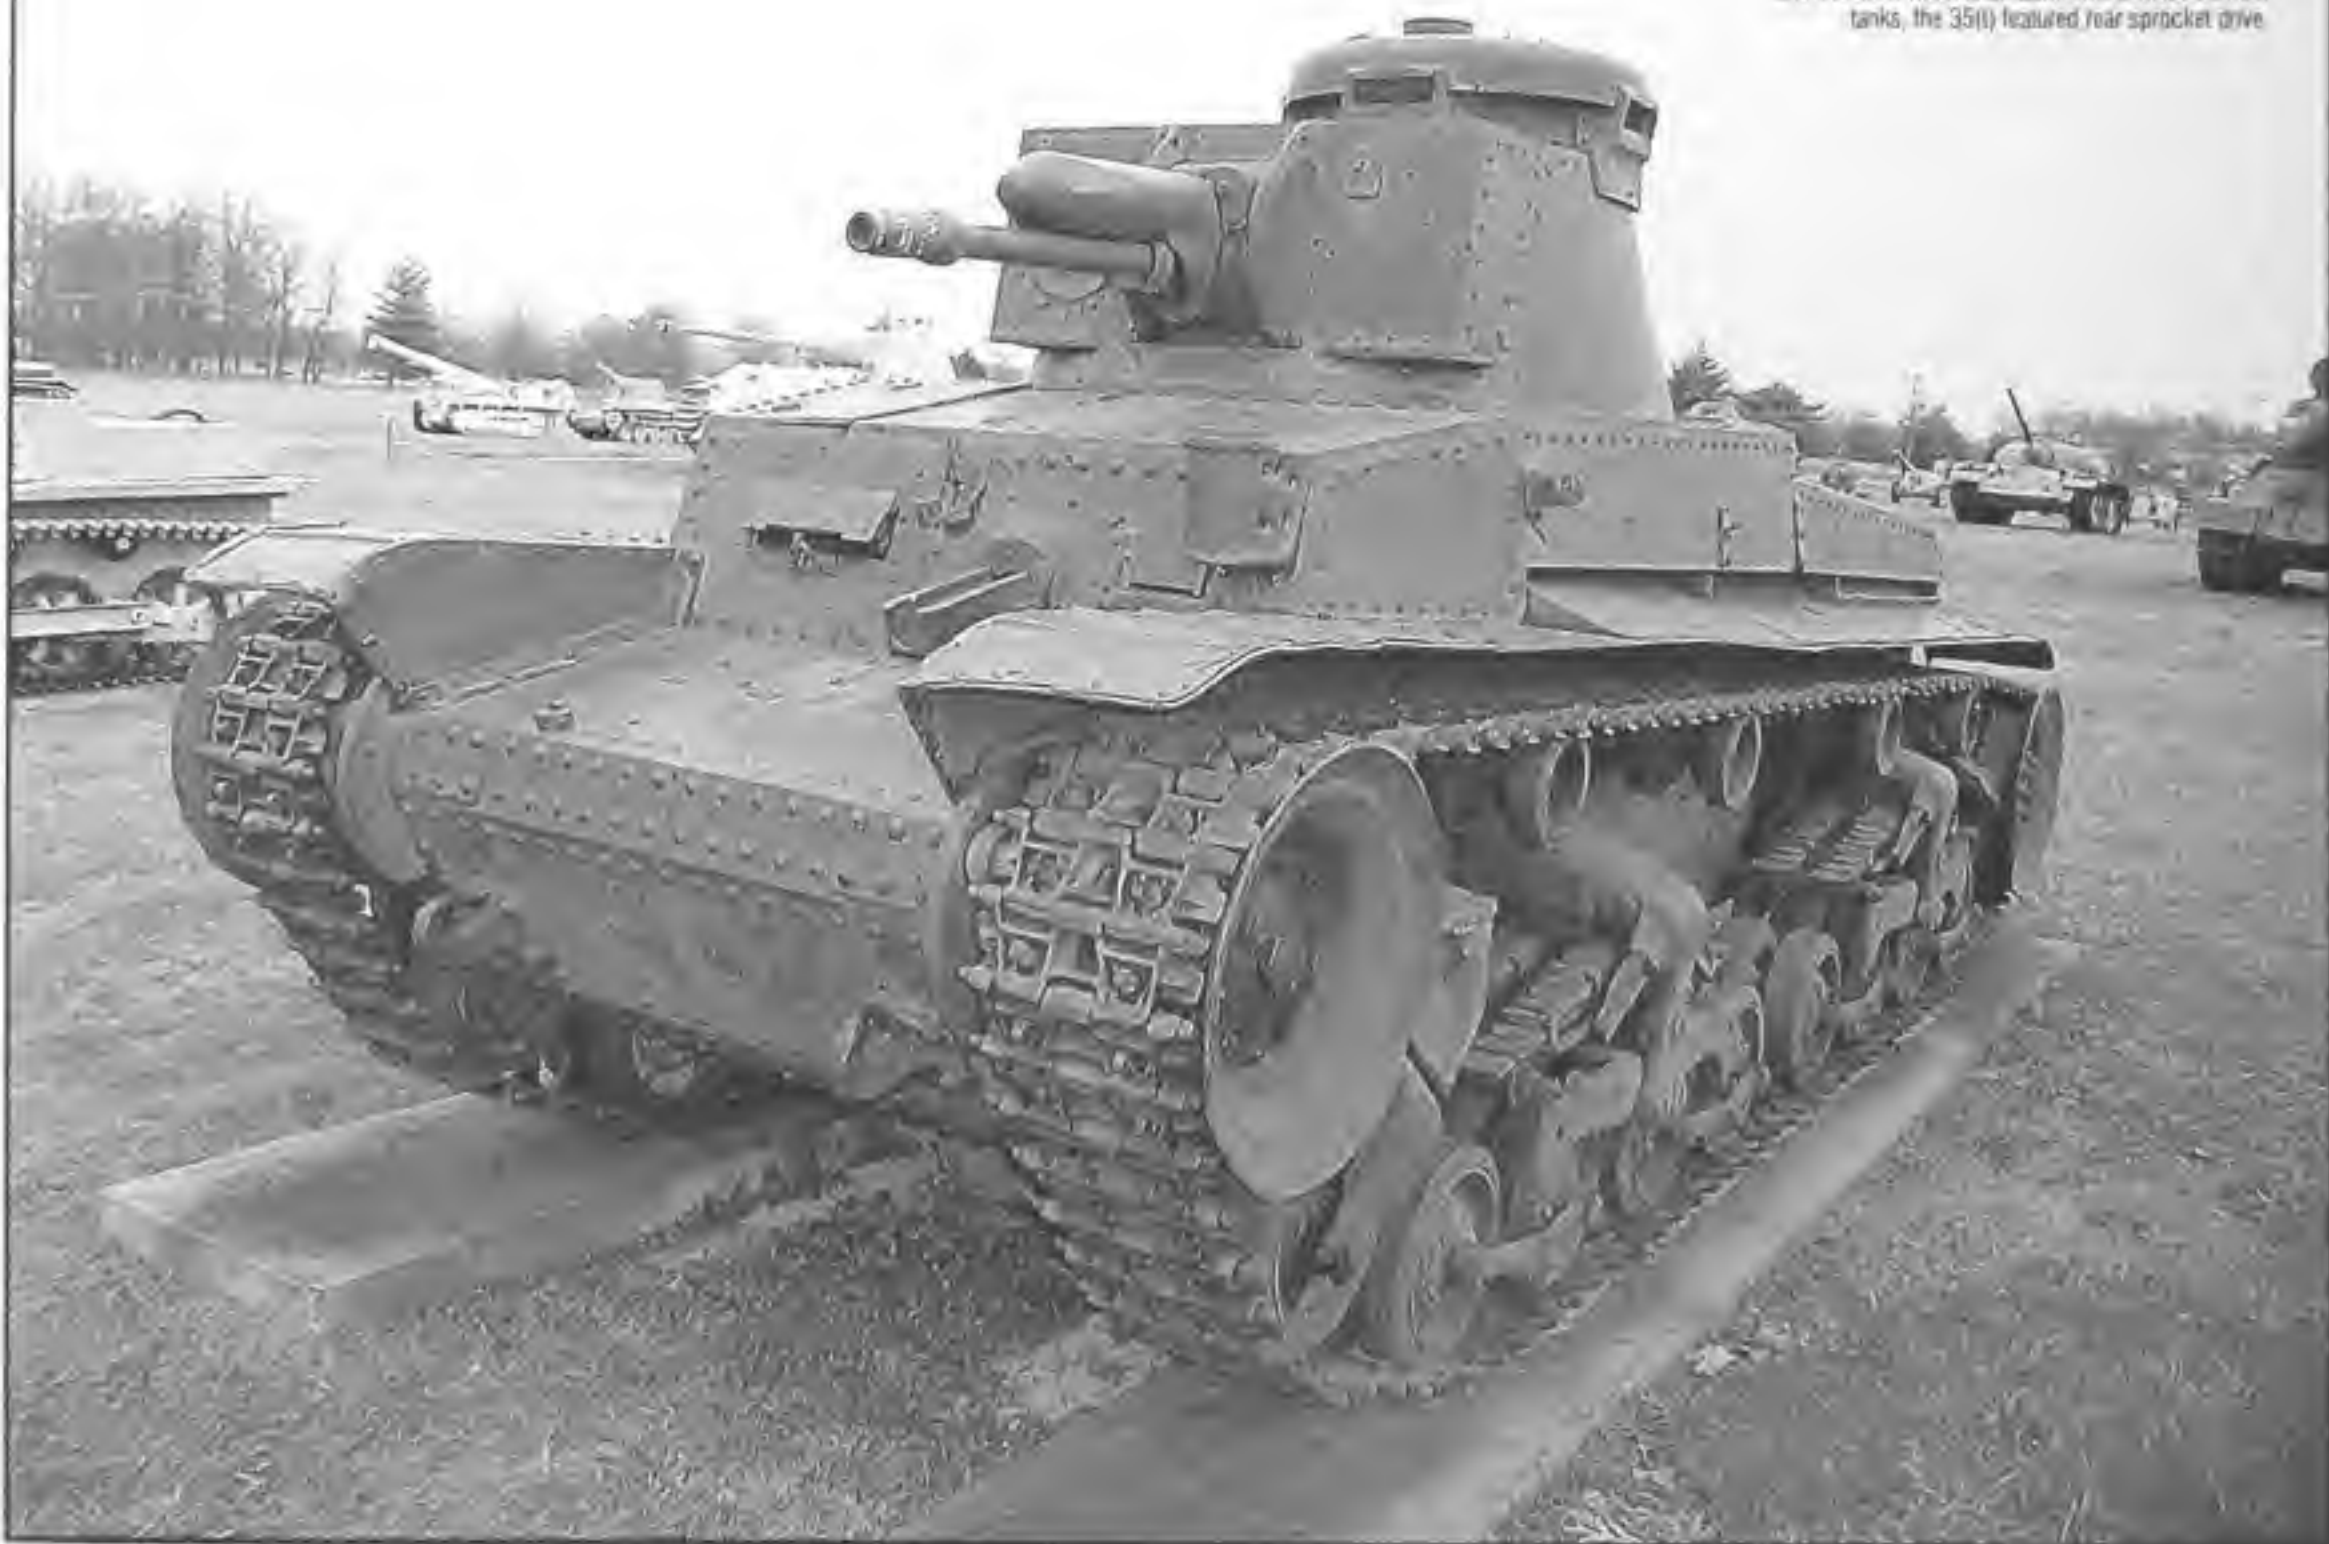
The suspension of the 35(t) consisted of two pairs of roadwheels each mounted on a central frame, with two frames per side. Each frame was sprung with a series of leaf springs. The roadwheel pairs each consisted of two wheels with rubber tires, for a total of eight per frame. The rubber of the wheels was susceptible to wear on long road marches.

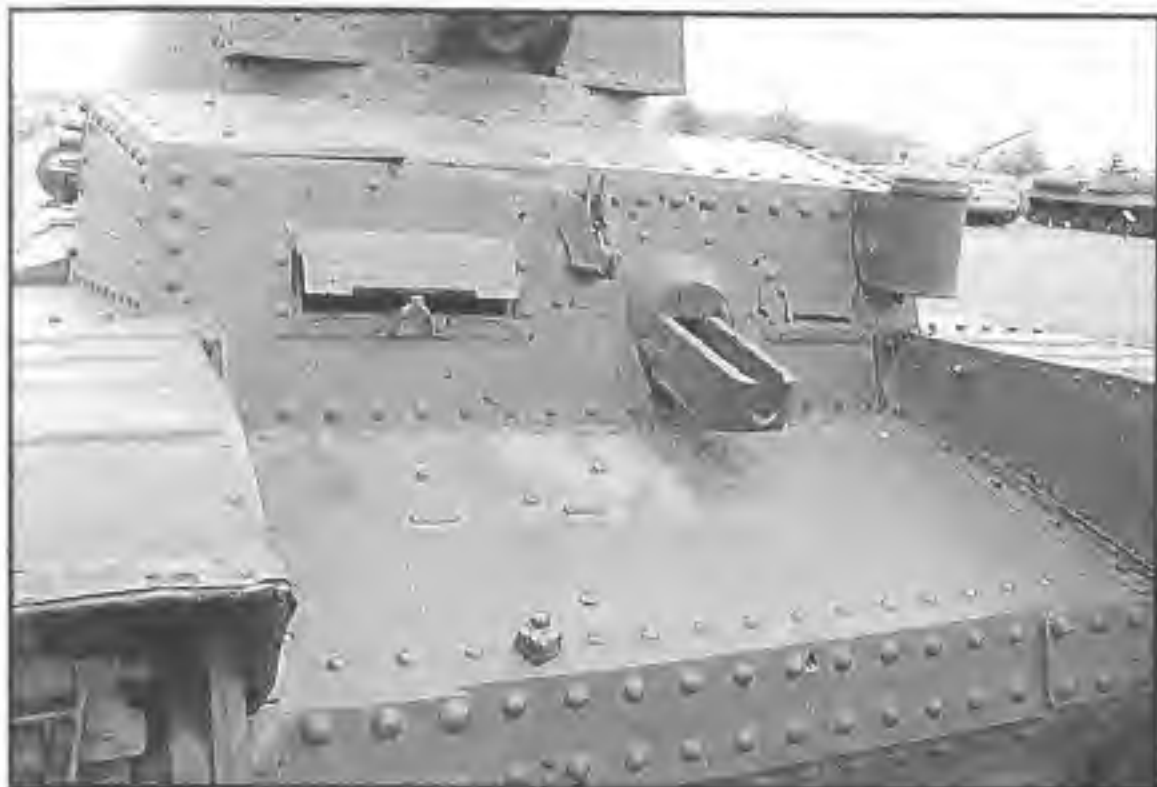
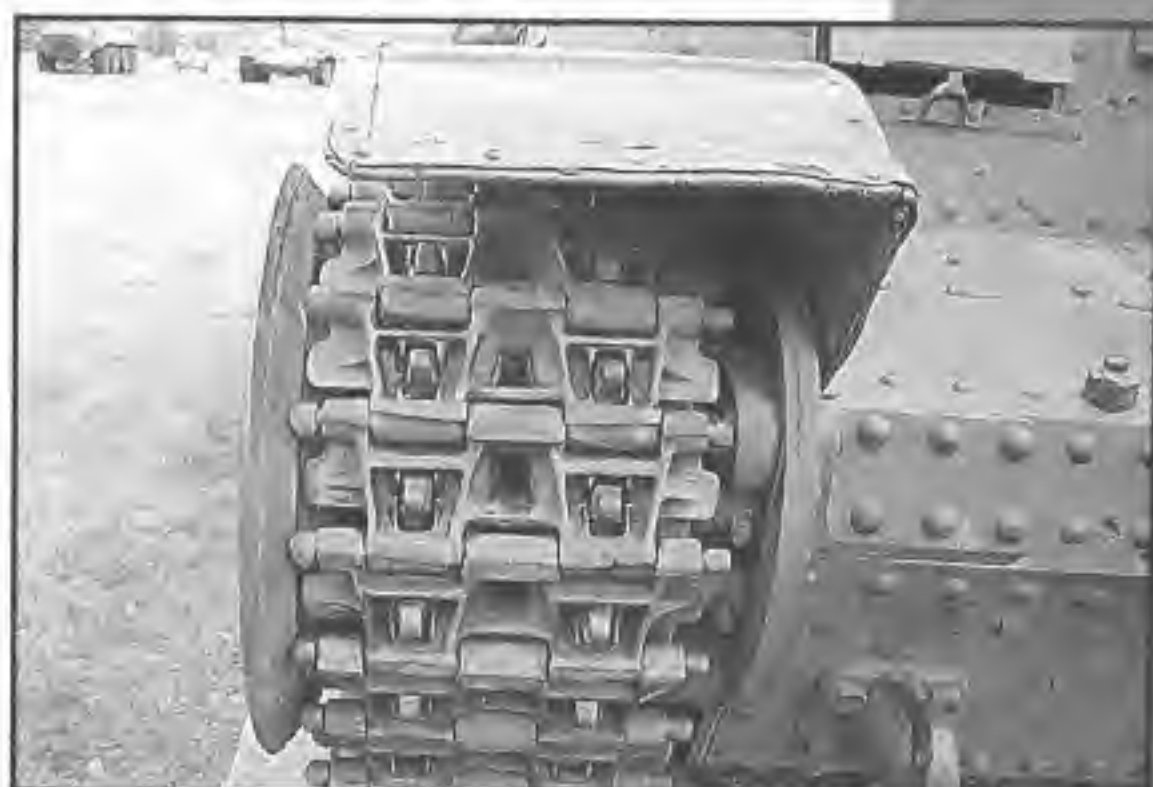
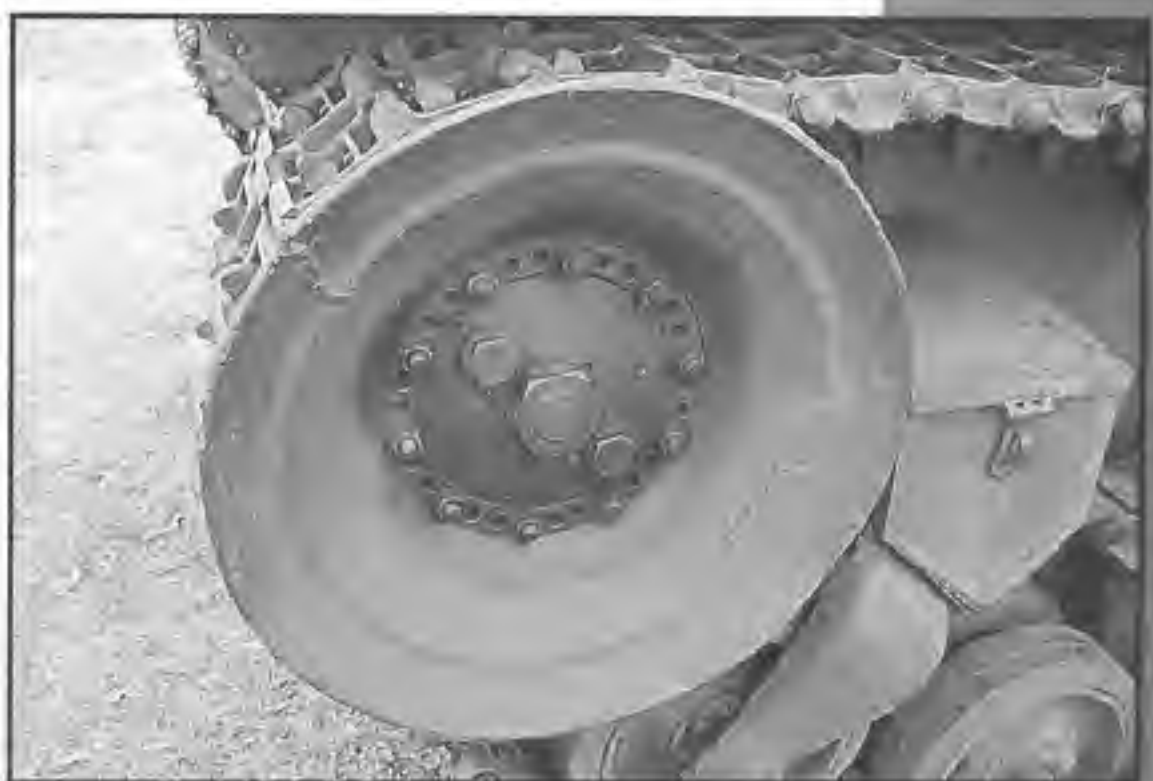
**Top left:** The driver's visor, now empty, normally held a piece of bulletproof glass, 50mm thick. The interior of the armored flap also held an episcopes with 25° field of view. The position for the radio operator's 7.9mm MG is also seen. The gun could be fired either over open sights, or using a telescope mounted in the radio operator's visor. The gun could also be locked in position and fired via a cable. In

this position, the rounds would strike at a distance of 250 meters in front of the tank. **Top right:** A close-up of the 27cm dry pin tracks. **Above left:** The armor on the 35(t) was either bolted or riveted to the hull using special armored fasteners. **Above right:** The front dished and toothed idler wheel.

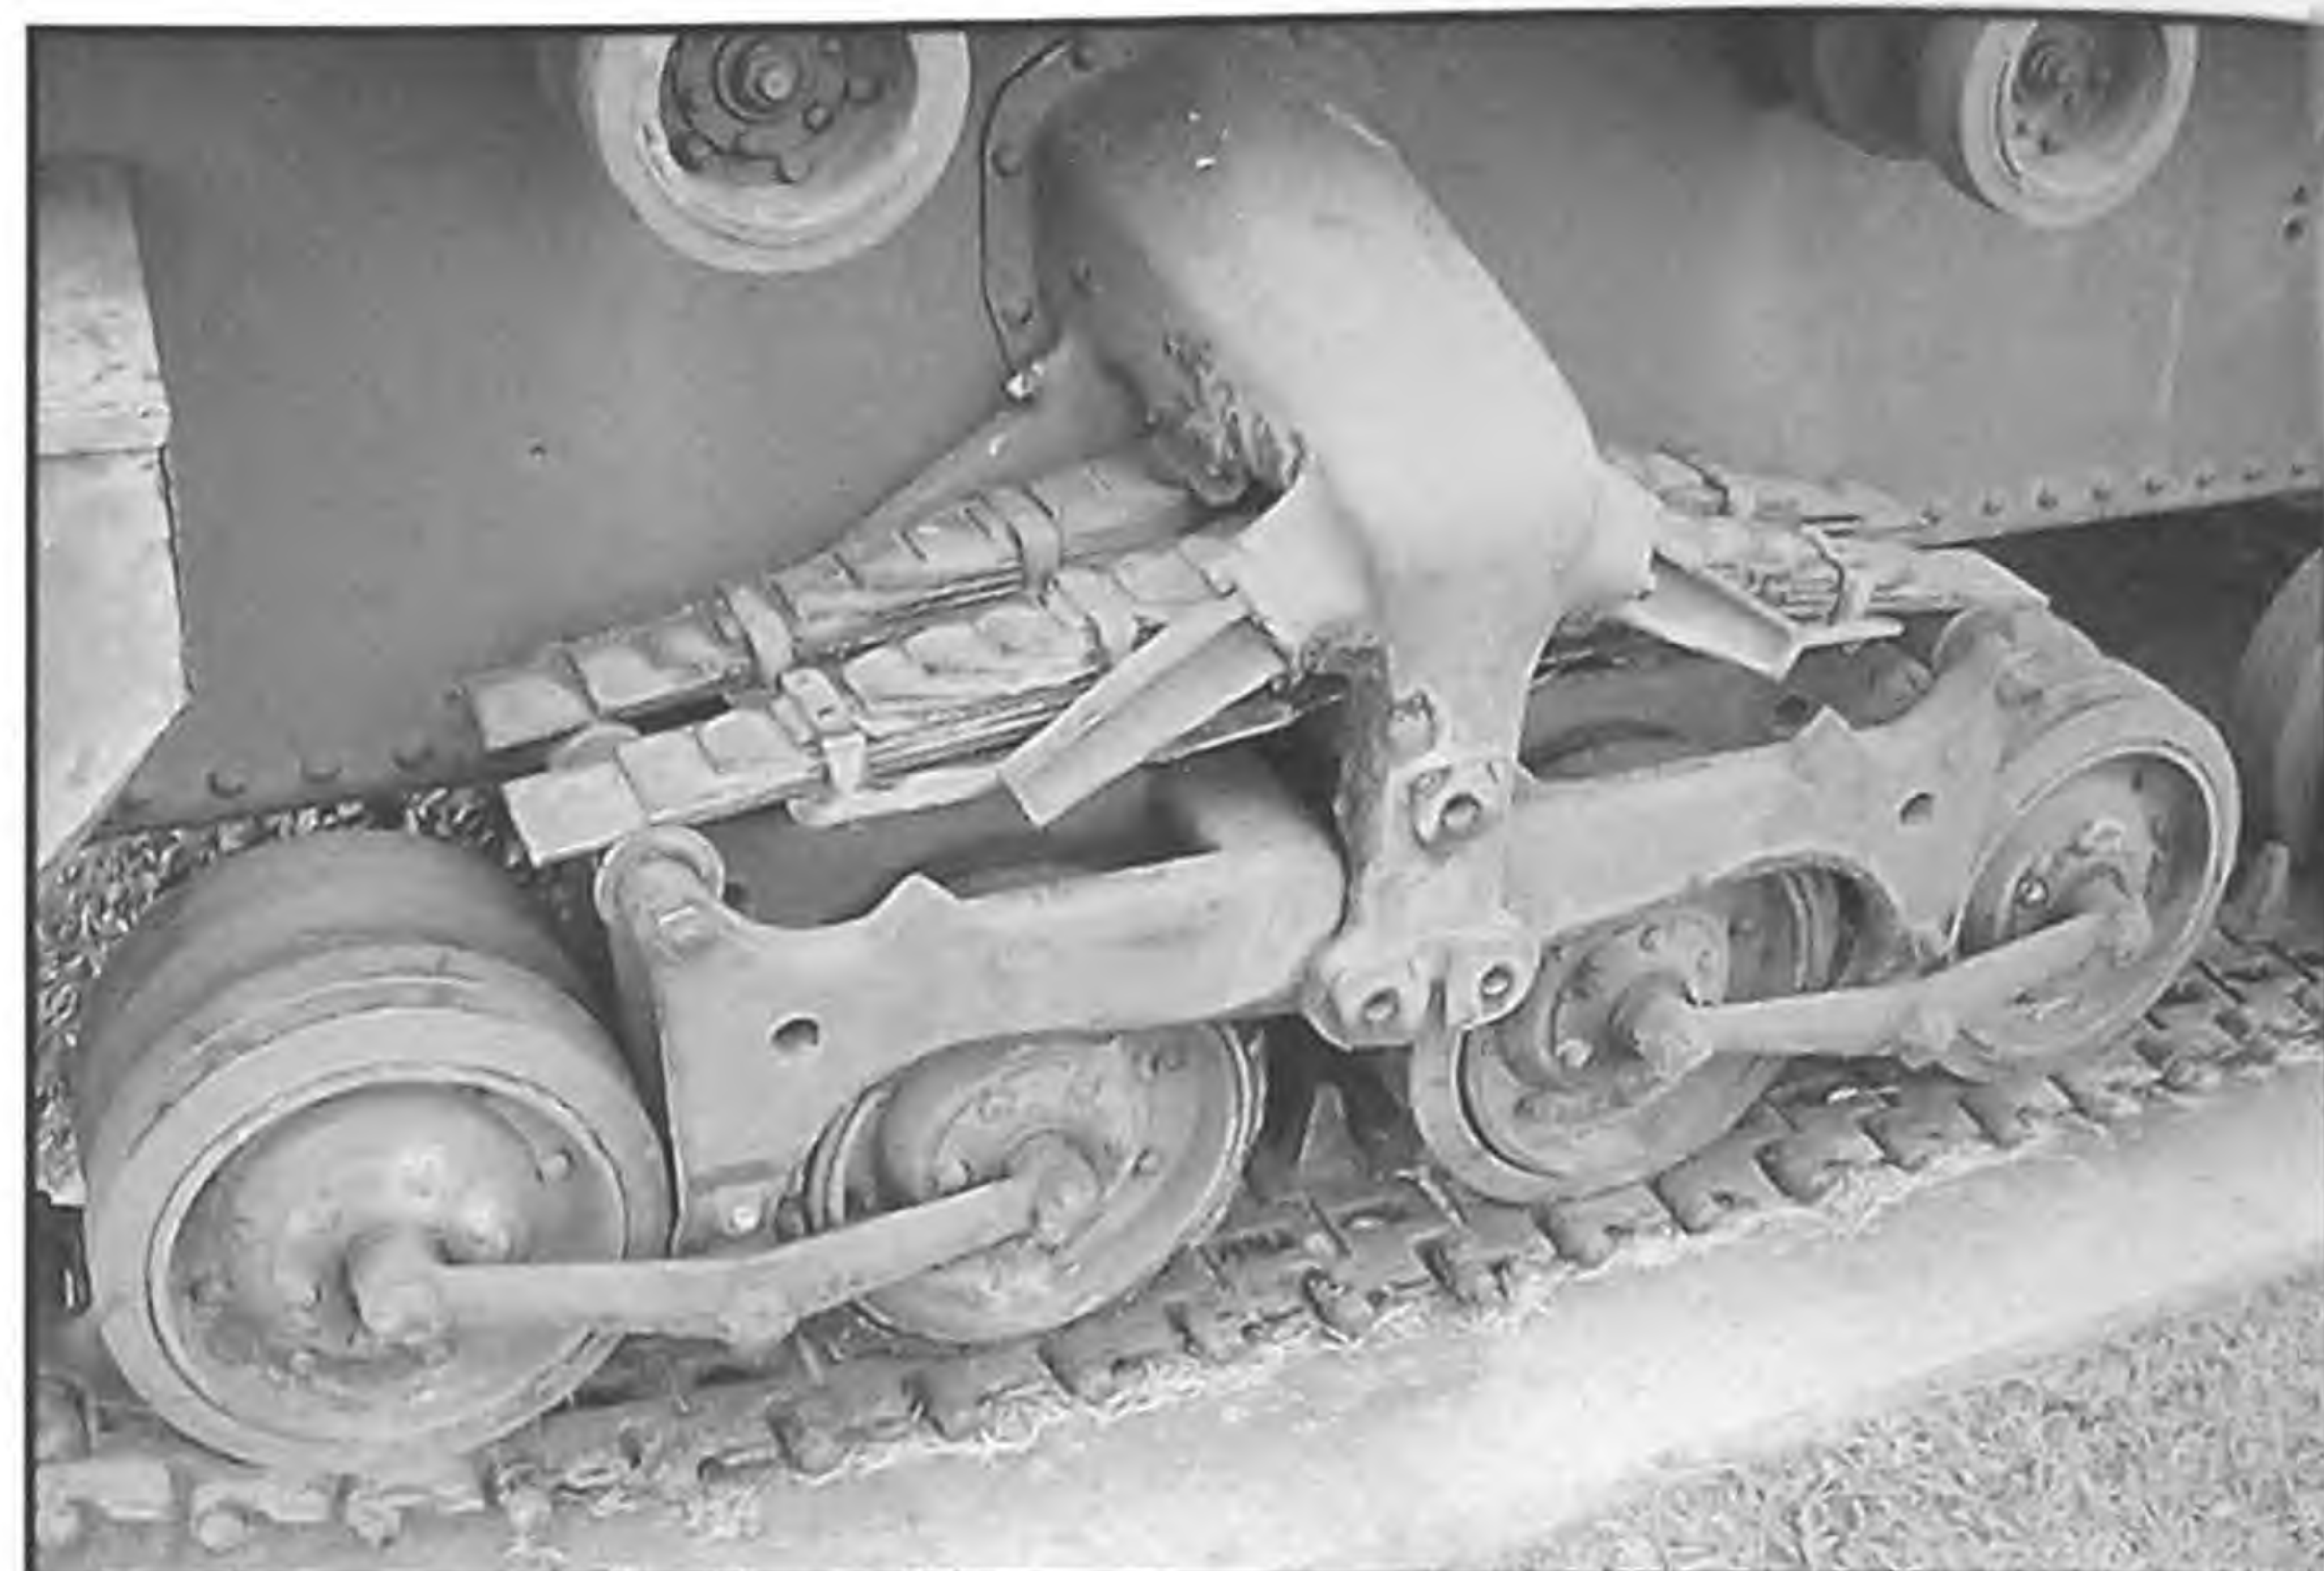
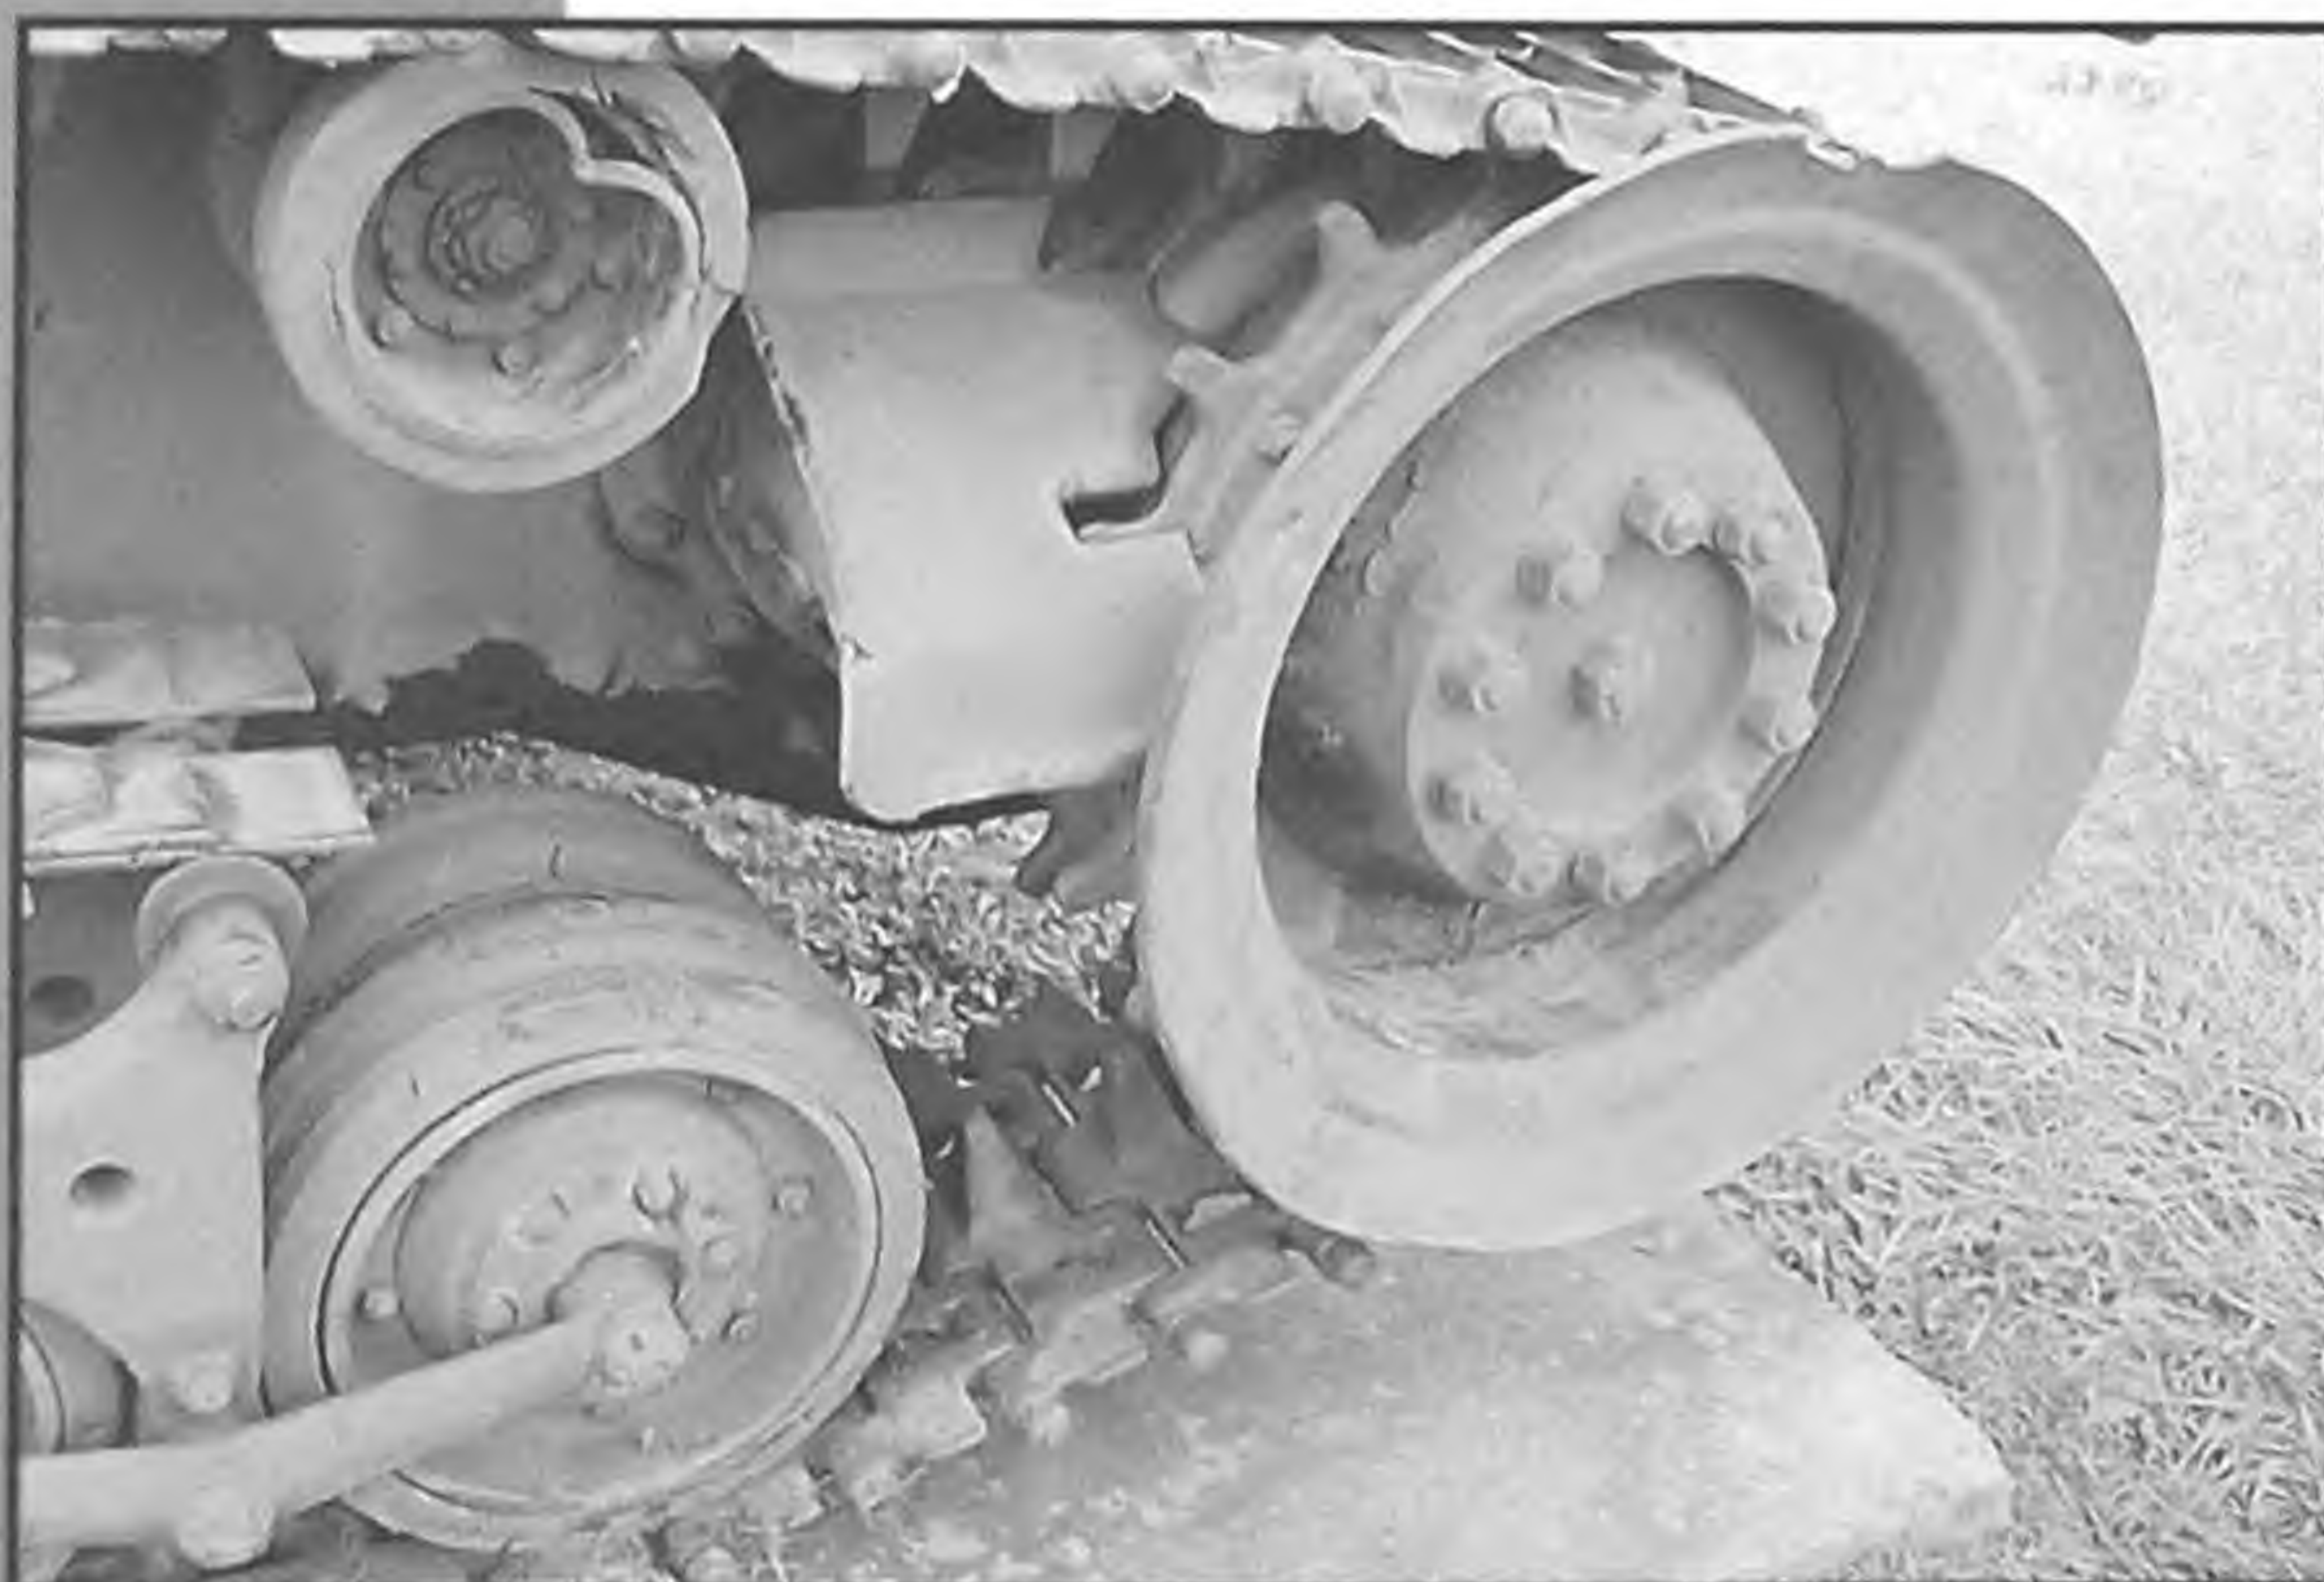
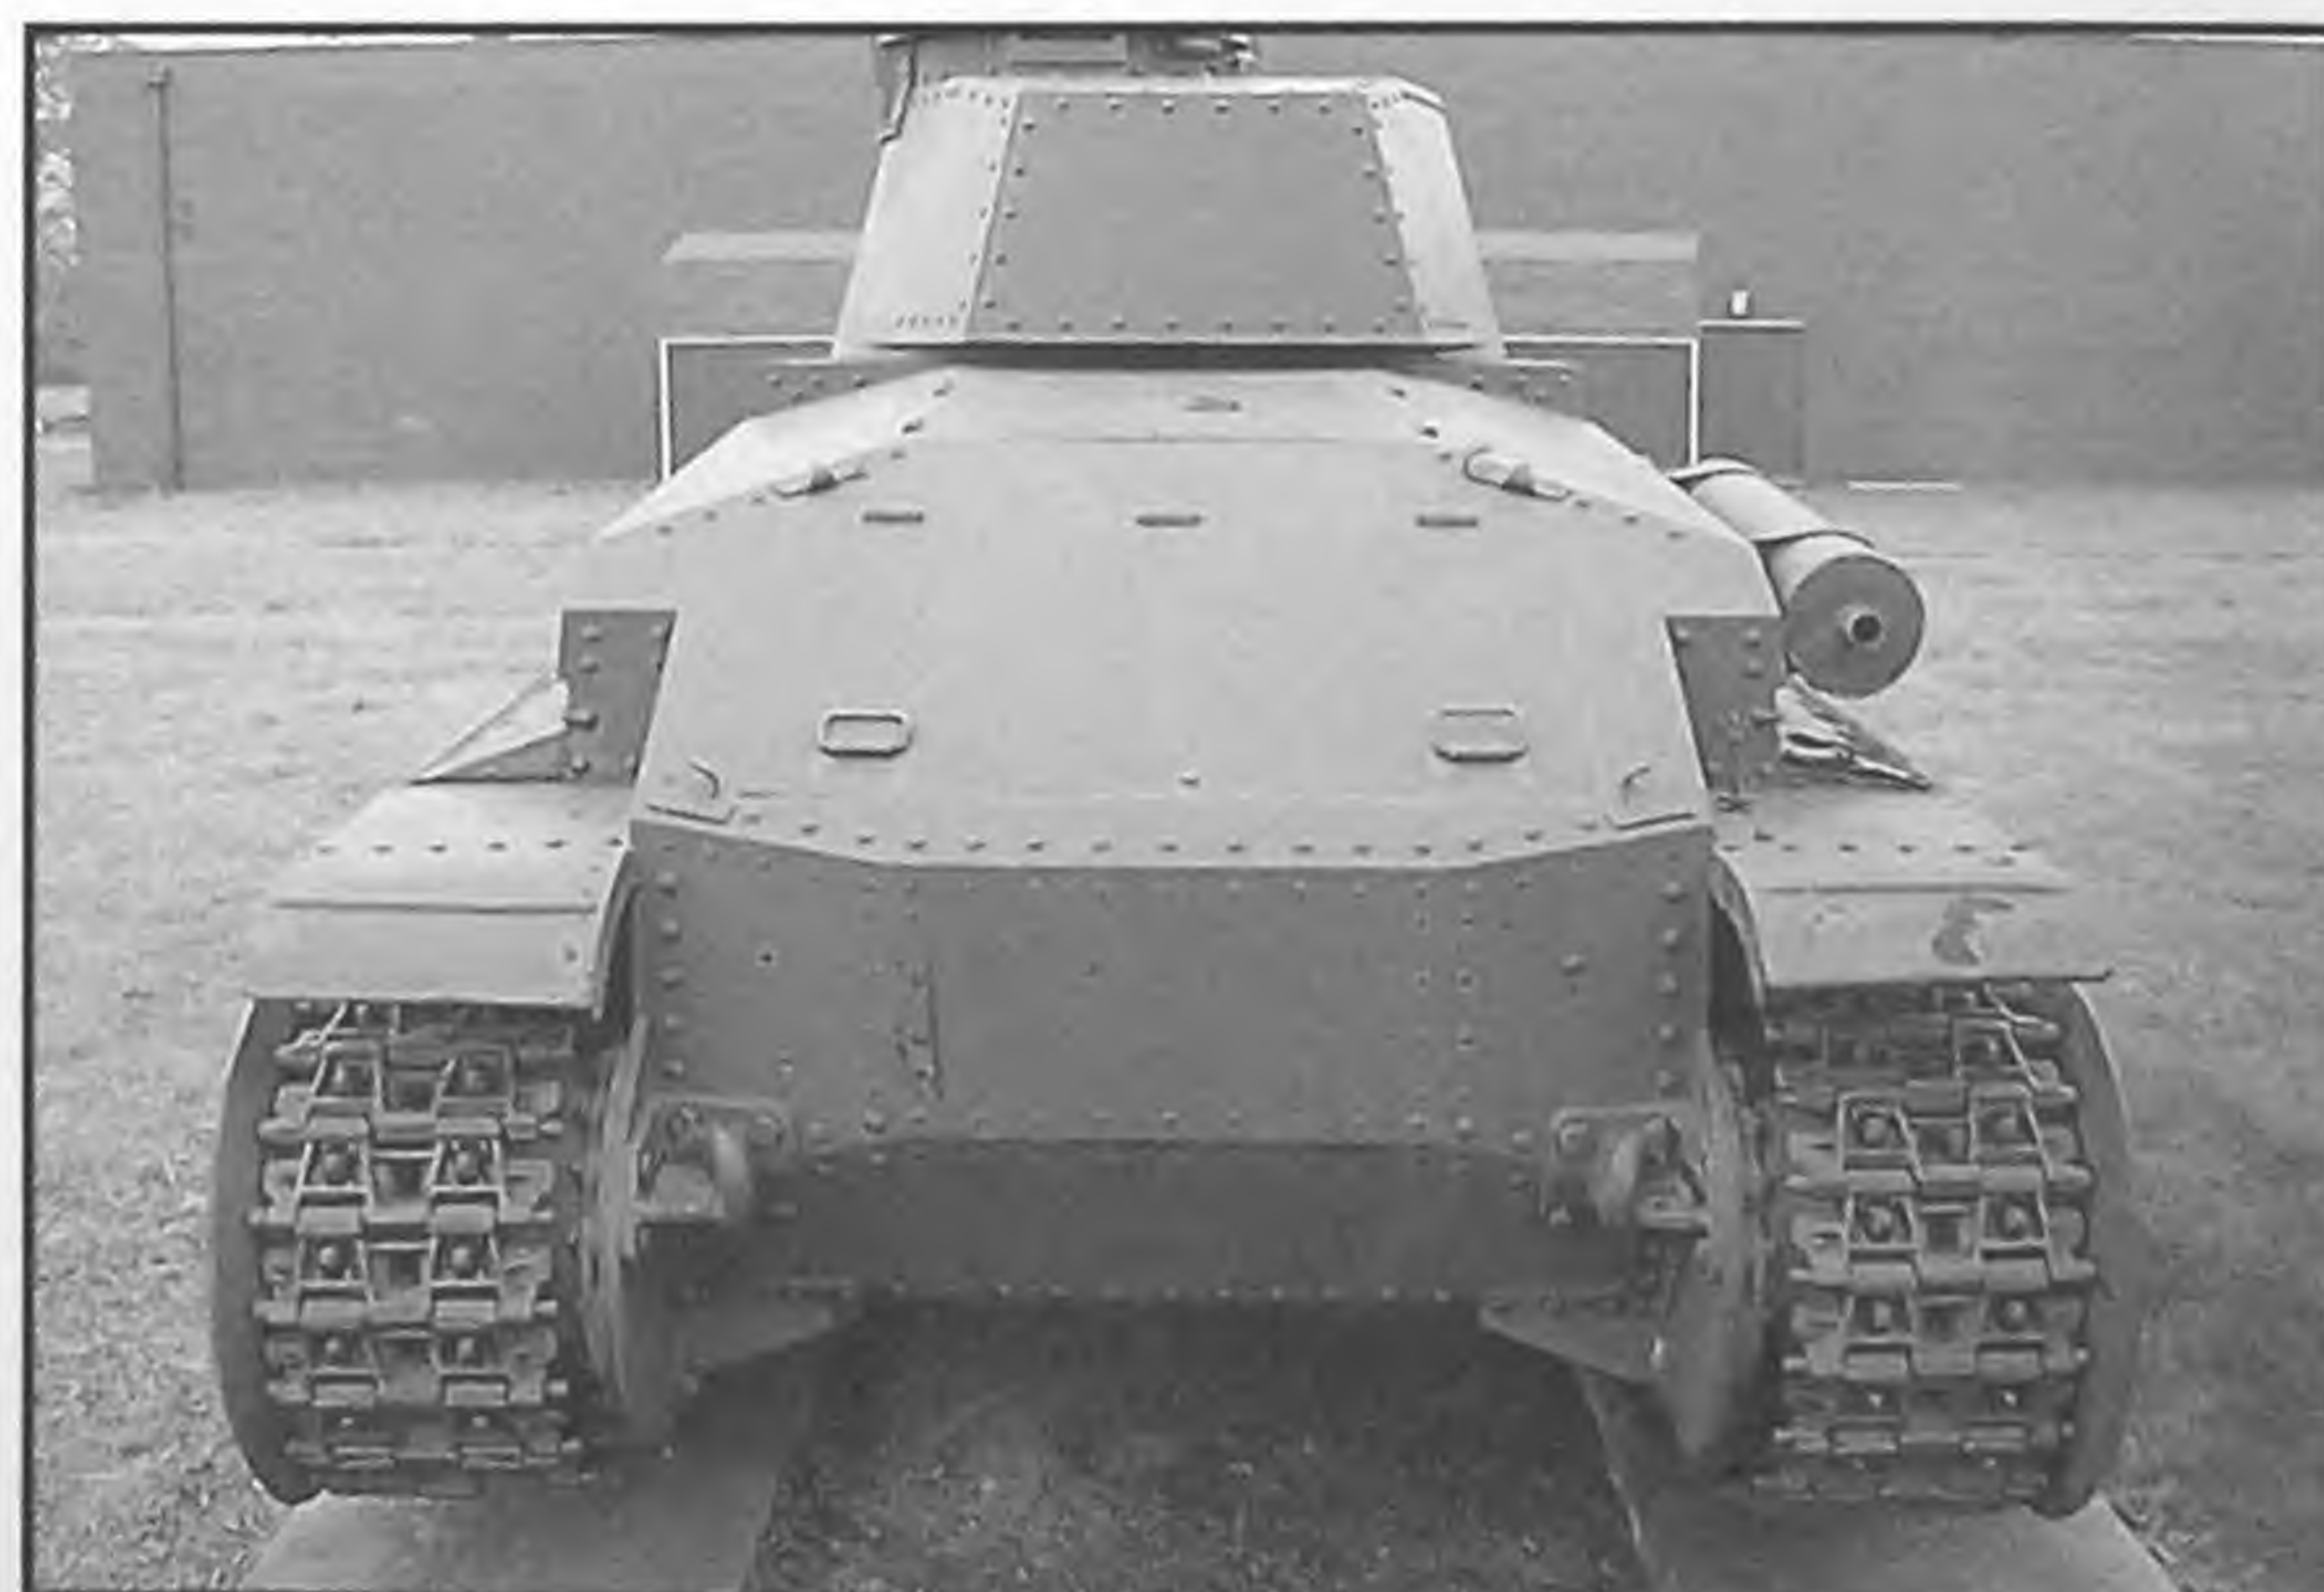
**Top left:** The front roadwheel was not sprung and it was installed in a fixed position. The locking box above it held track grousers. These could be installed on the tracks for extra grip in ice or snow. **Top right:** A closer view of the roadwheel frame. Twin sets of leaf springs were used on each frame. **Above**

**left:** The rear drive sprocket. Each of the two sprockets had 19 teeth and each also had a mud scraper installed, as can be seen in this shot. **Above right:** An overall view of the rear of the tank. The rear armor on the 35(t) was 8mm thick and the engine hatch itself was 10mm thick.
